CANADIAN FORCES FLIGHT SAFETY INVESTIGATION REPORT (FSIR)

FINAL REPORT

FILE NUMBER: 1010-124A419
DATE OF REPORT: 3 AUGUST 2001

AIRCRAFT TYPE: CH 124A Sea King
DATE/TIME: 1310Z, 4 MAY 99
LOCATION: SHEARWATER, NS
CATEGORY: "C" CATEGORY GROUND ACCIDENT

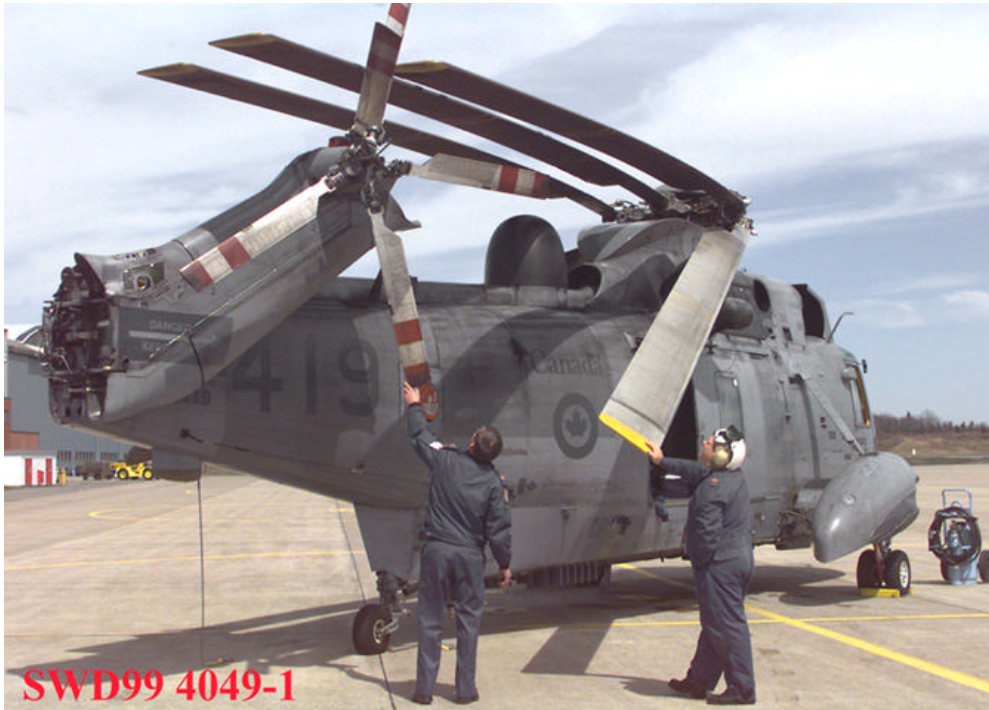
The output of a normal operating Sea King engine is up to 1350 shaft horsepower. When the number-2 engine SSL was advanced from ground idle towards the normal operating range (85-95 % Ng), the engine output exceeded the holding capacity of the rotor brake and the main rotor head began to rotate. The rotation of the main rotor head in the folded position directly caused all of the observed damage.

Figure 1 - 419 Drive Train Damage

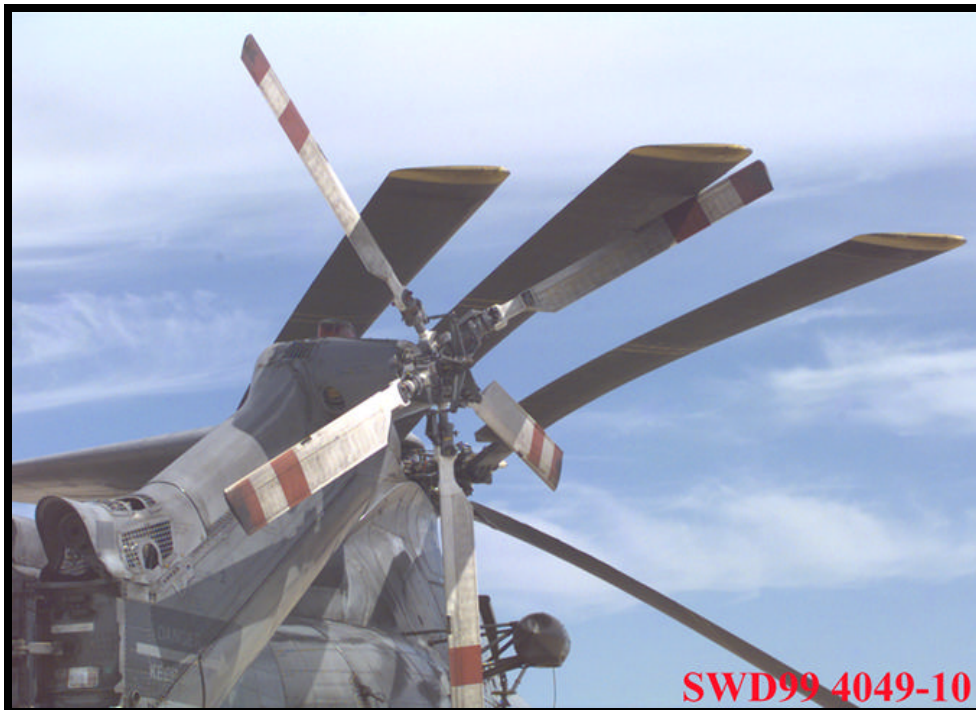
All five main rotor blades and two of the tail rotor blades sustained damage and required replacement. As well, the tail rotor gust lock, hub assembly, a pitch link and a pitch change beam sustained sufficient damage to require replacement. A 'Rotary Wing Sudden Stoppage Inspection' was utilised to determine the damage incurred on the Main Gearbox (MGB), the Main Rotor Head (MRH), Tail Rotor Drive shafts and the MGB oil cooler and blower assemblies; all were subsequently replaced by the contractor. Third line contractor repaired structural damage to the fuselage, tail cone and the strake.

Figure 2 - 419 Tail Rotor - Rear View
